**DEPARTMENT OF TRANSPORTATION****DIVISION OF ENGINEERING SERVICES**

Contract #: 04-0120F4Cty: SF/ALA Rte: 80 PM: 13.2/13.9File #: 69.28**WELDING INSPECTION REPORT****Resident Engineer:**Pursell, Gary**Address:** 333 Burma Road**City:** Oakland, CA 94607**Report No:** WIR-015779**Date Inspected:** 23-Jul-2010**Project Name:** SAS Superstructure**OSM Arrival Time:** 700**Prime Contractor:** American Bridge/Fluor Enterprises, a JV**OSM Departure Time:** 1900**Contractor:** Zhenhua Port Machinery Company, Ltd (ZPMC), Changxing Island **Location:** Shanghai, China**CWI Name:** Mr. Xu Le Feng**CWI Present:** Yes No**Inspected CWI report:** Yes No N/A**Rod Oven in Use:** Yes No N/A**Electrode to specification:** Yes No N/A**Weld Procedures Followed:** Yes No N/A**Qualified Welders:** Yes No N/A**Verified Joint Fit-up:** Yes No N/A**Approved Drawings:** Yes No N/A**Approved WPS:** Yes No N/A**Delayed / Cancelled:** Yes No N/A**Bridge No:** 34-0006**Component:** Tower**Summary of Items Observed:**

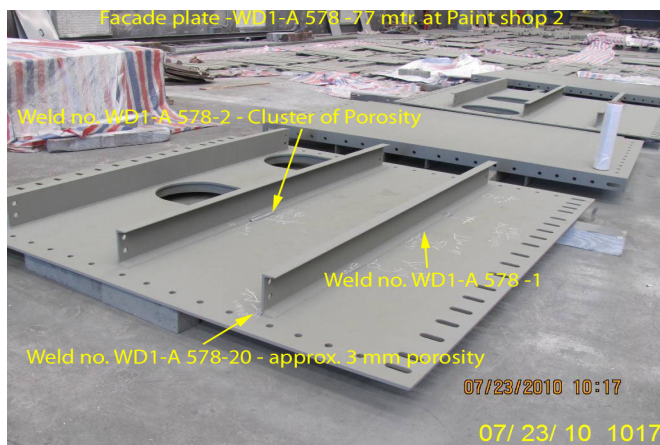
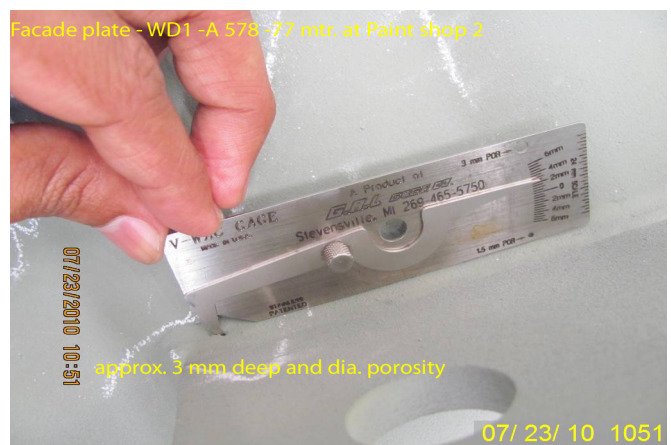
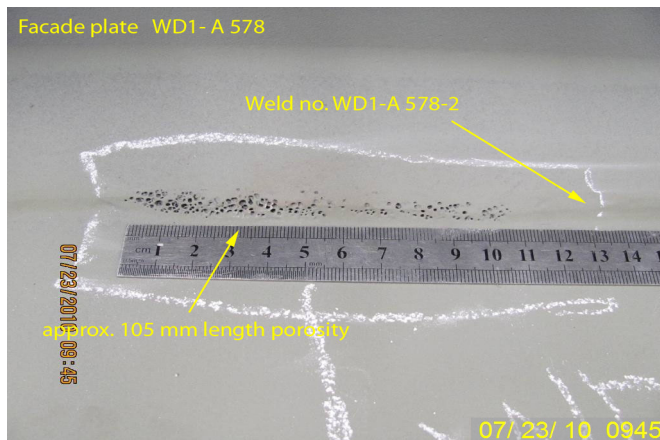
This QA inspector, Baskar Govindarajan, observed During the Quality Assurance Inspection of Façade plate, Approx. 105 mm length, cluster of porosity observed in weld no WD1- A 578-2, approx. 3mm deep and 3mm dia. Porosity observed in weld no. WD1- A 578- 20 and approx. 6 mm deep fusion discontinuity observed in weld no. WD1- A 578-1. The façade plate is now coated with primer (Interzinc 22). These weld repair locations has been taped for weld Repair after the coating work done. This QA Inspector wrote an Incident report on this issue. Please see the attaché photos for further details.
